**PIPELINE OBSERVATION SYSTEM MANAGEMENT**
**Project Information**

# Project: CITY OF MOUNTAIN VIEW

Upstream MH: F5-54

Downstream MH: F5-52

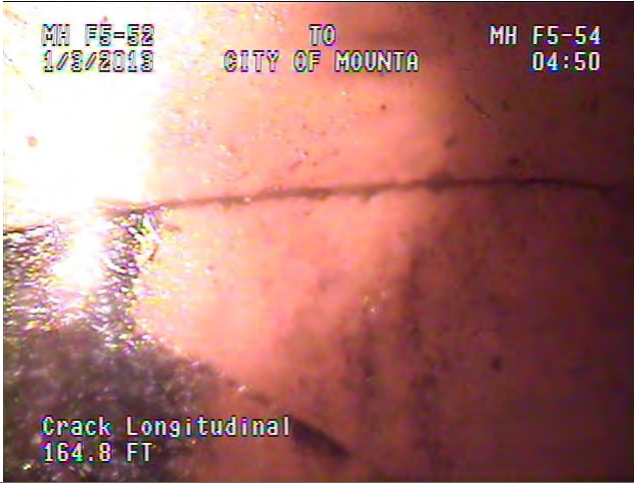
164.8	Crack Longitudinal Position: 12 Severity: None Struct Weight: 2	06:45

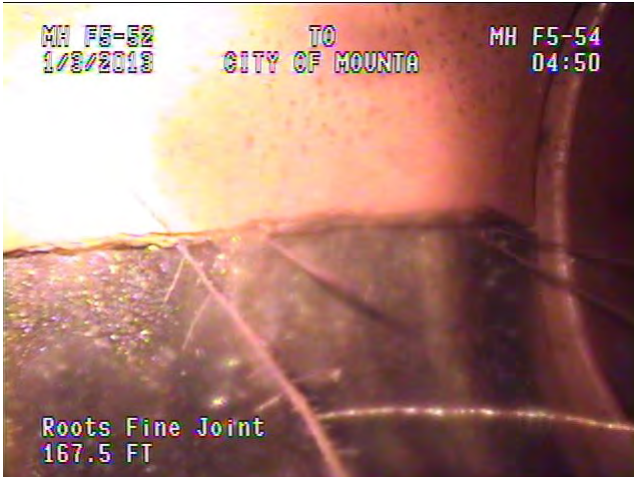
167.5	Roots Fine Joint Position: 10 Severity: None Joint Maint Weight: 1	07:05

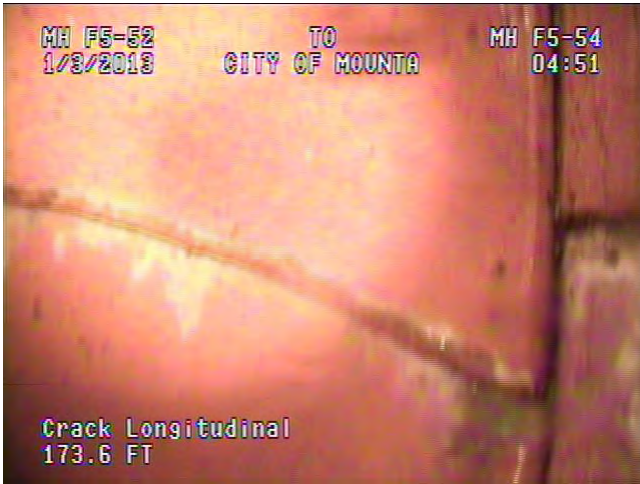
Distance	Fault Observation	Time	Picture
173.6	Crack Longitudinal Position: 2 Severity: None Struct Weight: 2	07:33

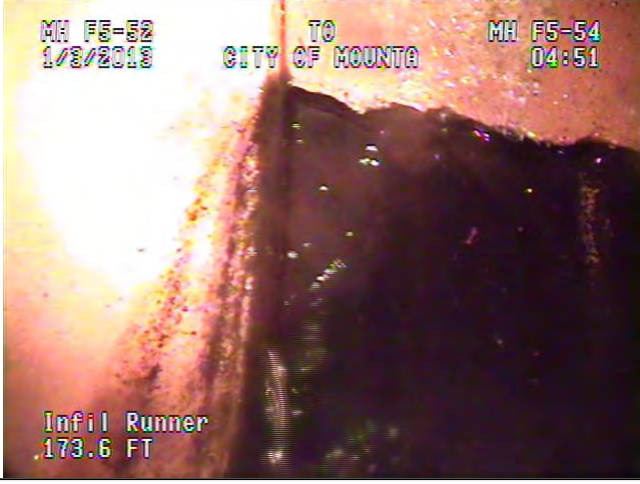
173.6	Infil Runner Position: 3 Severity: None Maint Weight: 4	07:50

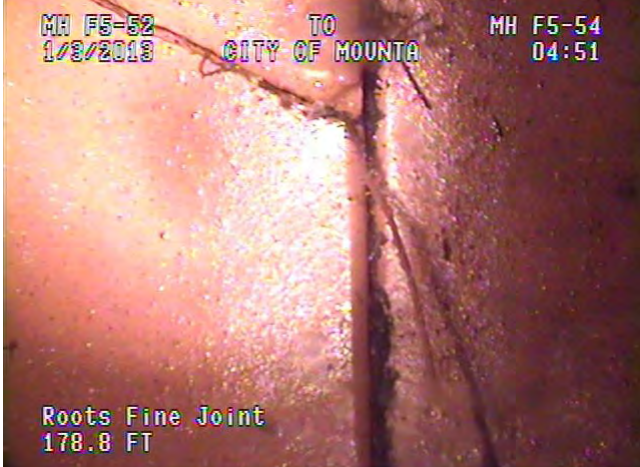
178.8	Roots Fine Joint Position: 1 Severity: None Joint Maint Weight: 1	08:14

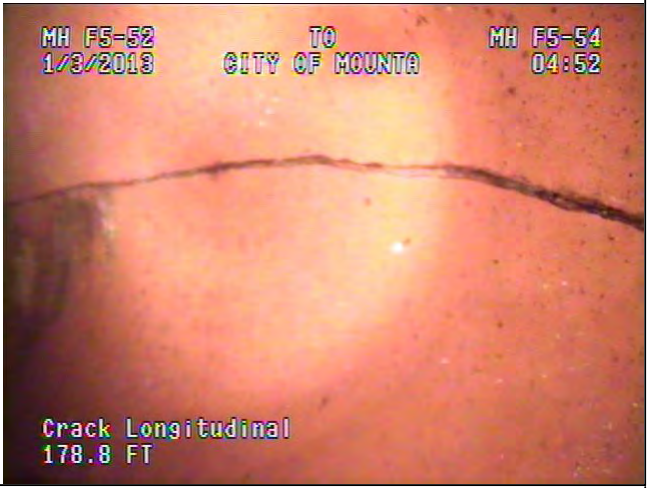
Distance	Fault Observation	Time	Picture
178.8	Crack Longitudinal Position: 1 Severity: None Struct Weight: 2	08:30

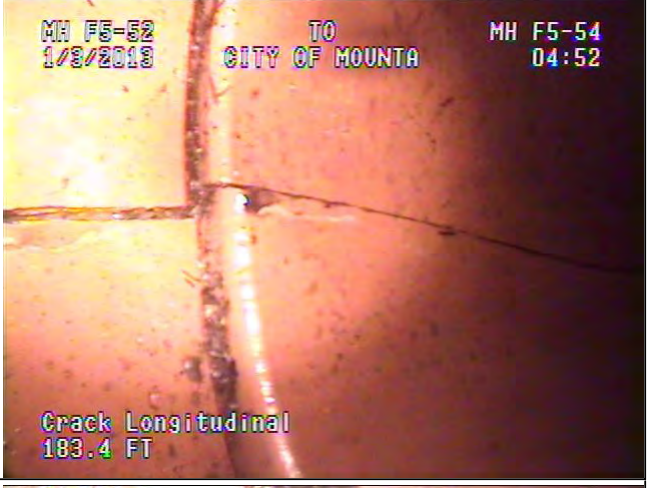
<p>MH F5-52 1/8/2018 TO CITY OF MOUNTA MH F5-54 04:52</p> <p>Crack Longitudinal 178.8 FT</p>
183.4	Crack Longitudinal Position: 12 Severity: None Struct Weight: 2	08:56

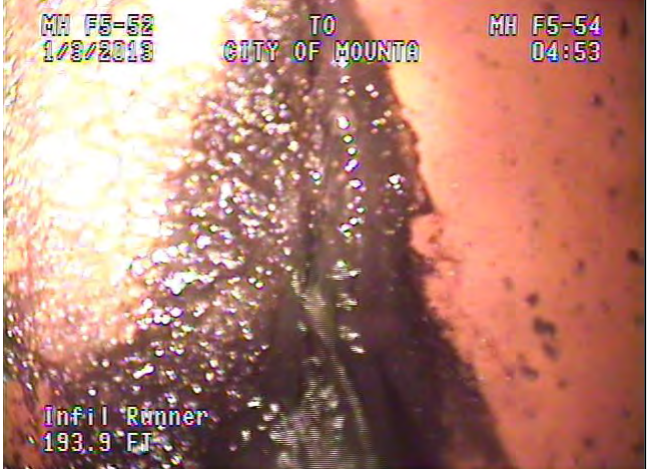
<p>MH F5-52 1/8/2018 TO CITY OF MOUNTA MH F5-54 04:52</p> <p>Crack Longitudinal 183.4 FT</p>
193.9	Infil Runner Position: 9 Severity: None Maint Weight: 4	09:29

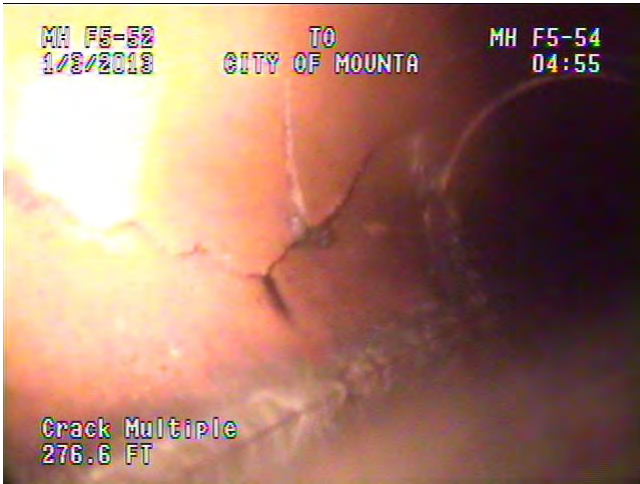
Distance	Fault Observation	Time	Picture
276.6	Crack Multiple Position: 6 To 9 Severity: None Struct Weight: 3	12:03

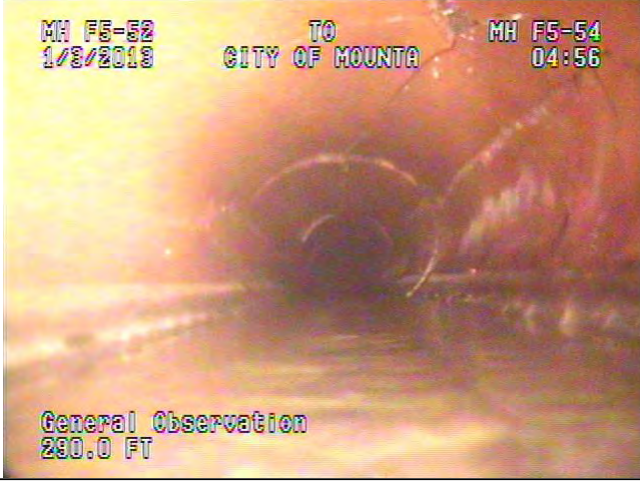
<p>MH F5-52 TO MH F5-54 1/3/2013 CITY OF MOUNTA 04:55</p> <p>Crack Multiple 276.6 FT</p>
290.0	General Observation Severity: None Remarks: Pipe looks egg shaped	13:02

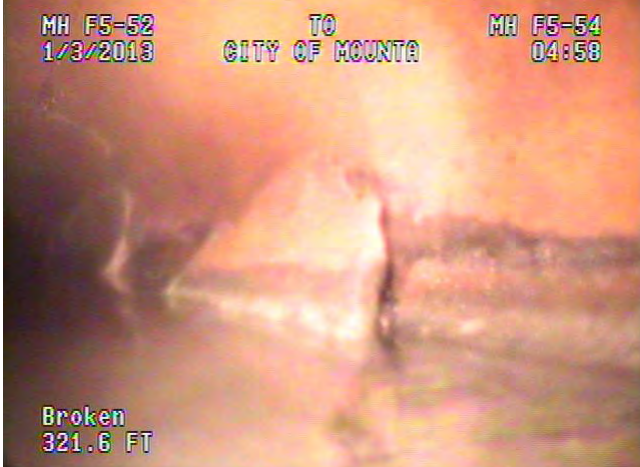
<p>MH F5-52 TO MH F5-54 1/3/2013 CITY OF MOUNTA 04:56</p> <p>General Observation 290.0 FT</p>
321.6	Broken Position: 9 Severity: None Struct Weight: 3	14:32

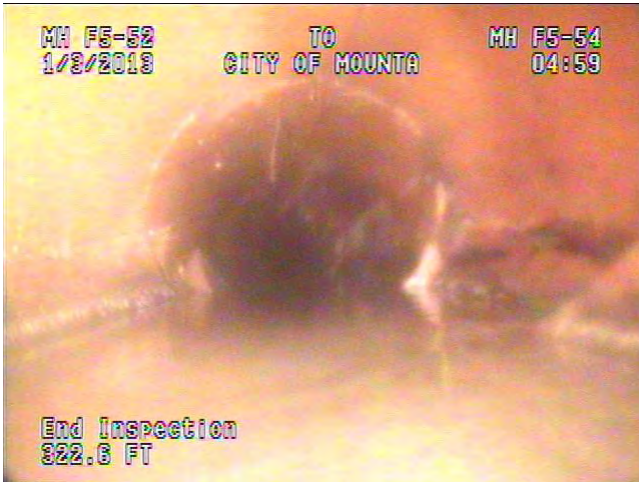
Distance	Fault Observation	Time	Picture
322.6	<p>End Inspection Severity: None Remarks: cannot pass break at 6 o'clock.</p>	15:21
